In-situ SEM observations of ultrasonic cavitation erosion behavior of HVOF-sprayed coatings

Haijun Zhang^a, Xiuyong Chen^{a,b,c,*}, Yongfeng Gong^a, Ye Tian^a, André McDonald^c, Hua Li^{a,b,*}

ABSTRACT

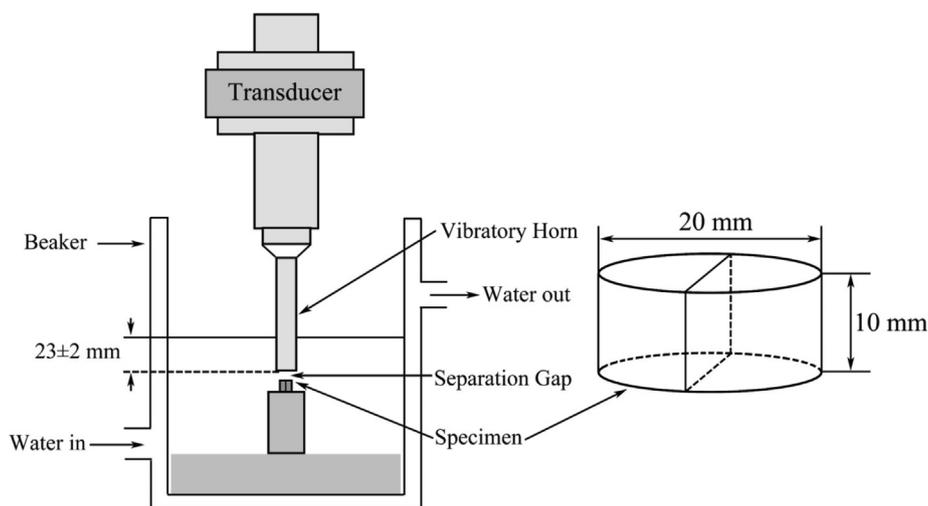
Fig. 1. Schematic diagram of the cavitation erosion test system.

The cavitation tests were performed by utilizing an ultrasound device (GBS-SCT 20A, Guobiao Ultrasonic Equipment Co., Ltd., Hangzhou, China) with a 1500 W output power, a peak-to-peak amplitude of 50 μm and a 20 kHz output frequency, in accordance with the ASTM G32-16 standard [21]. The schematic of the cavitation erosion equipment is shown in Fig. 1. Before the cavitation erosion tests, the surfaces of the coatings were polished, and for *in-situ* SEM observation, the samples were cut into two equal parts with a cutting machine (SYJ-200, MTI Corporation, USA). The cross-section of the coating was polished to a mirror finish, cleaned with acetone, dried with warm air, and then marked in a specific place to record the original images by SEM. Deionized water was chosen as the test liquid and the vibratory horn was immersed into the water to a depth of 23 mm. The test temperature was maintained at $25 \pm 1^\circ\text{C}$ by circulating fresh water in the cooling bath. The cavitation tests were performed for 35 h in total, with time intervals of 4, 8, 15, 25, and 35 h. The mass losses of the coating samples were recorded after each of cavitation exposure period intervals. After the cavitation tests, all of the coating samples were degreased, rinsed, dried, and then weighed to determine the mass losses. The samples were weighed by using an electronic analytical balance (METTLER 220, TOLEDO Instruments Co., Ltd., Shanghai, China). Each test was repeated three times. The volume loss (V_{loss}) and the rate of volume loss (\dot{V}_{loss}) were used to indicate the cavitation resistance in this

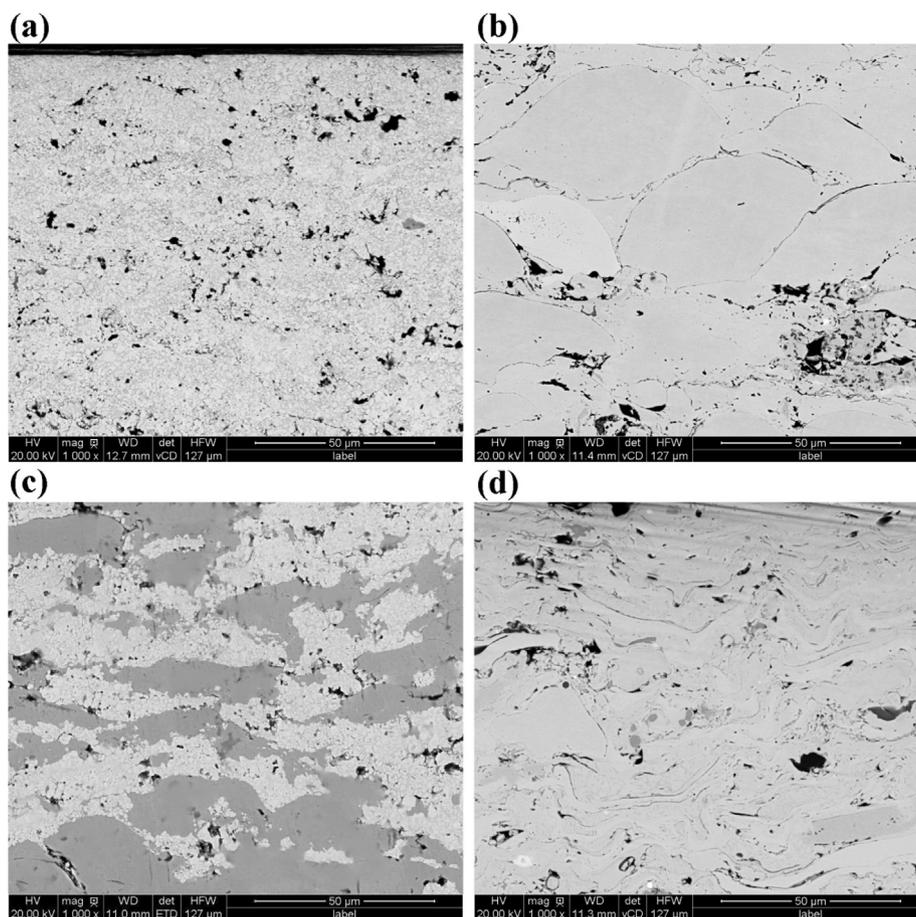
Fig. 2. FESEM cross-sectional morphologies of the (a) WC-10Co4Cr coating, (b) Co-based coating, (c) WC-10Co4Cr/Co-based composite coating, and (d) Fe-based amorphous/nanocrystalline coating.

The microstructure of the coatings was analyzed in order to identify the salient features that would have an impact on the cavitation resistance of the coatings. Fig. 2 shows typical regions of the polished cross-sections of the coatings. The average porosities of these coatings were less than 2.5% (see Table 1), which is consistent with previous

studies [22,23]. Pores were observed in the WC-10Co4Cr coatings (Fig. 2a). Cobalt-based coatings, with partially molten particles, were obtained (Fig. 2b). The presence of partially molten particles in the coatings was likely due to the short residence time of the feedstock powder particles in the HVOF spray flame, which in turn led to a rough surface with pores and cracks [24]. The WC-10Co4Cr and Co-based phases were distinctly present in the WC-10Co4Cr/Co-based composite coating (see Fig. 2c). Lamellar structures and some defects (pores) were observed in the Fe-based amorphous/nanocrystalline coating (Fig. 2d). The larger pores were predominantly due to the loose packing of the layered structure of the coating, while the smaller pores in the coating were likely formed during shrinkage porosity, as suggested by Zhou, et al. [25] and Sobolev, et al. [26].

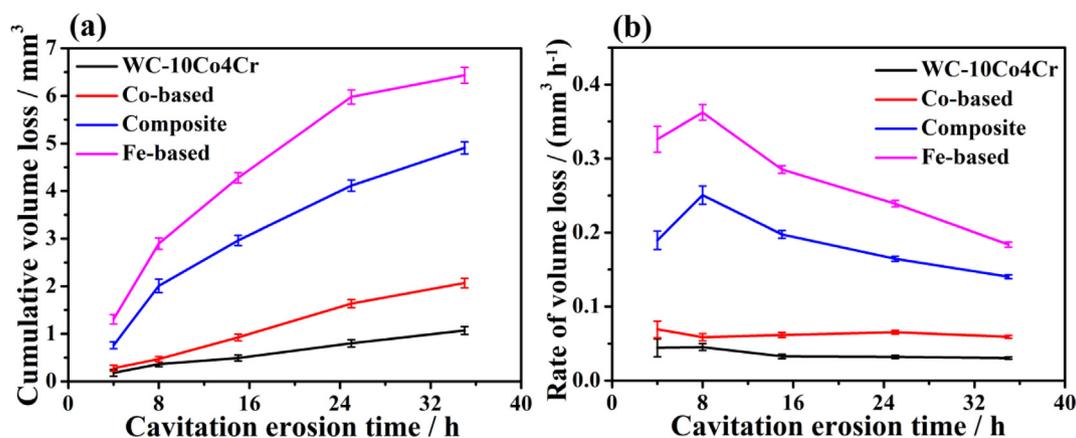
Fig. 3. (a) Cumulative volume loss and (b) rates of volume loss of the WC-10Co4Cr coating, Co-based coating, WC-10Co4Cr/Co-based composite coating, and Fe-based amorphous/nanocrystalline coating after cavitation exposure of 35 h in deionized water.

Failure and material loss of the coatings are expected during exposure to the cavitation process. Fig. 3 shows the cumulative volume loss and rates of volume loss of the coatings after cavitation exposure for 35 h in deionized water. The results showed that after 35 h of cavitation erosion, the cumulative volume losses of the WC-10Co4Cr coating, Co-based coating, WC-10Co4Cr/Co-based composite coating, and Fe-based amorphous/nanocrystalline coating were approximately 1.1 mm³, 2.1 mm³, 4.9 mm³, and 6.4 mm³, respectively (see Fig. 3a). All the coating samples experienced volume loss during cavitation exposure, and the losses increased steadily with time during the exposure period. The cavitation erosion resistance was characterized by the volume loss rates, as shown in Fig. 3b, with the WC-10Co4Cr coating presenting with the lowest loss rate and the highest cavitation erosion

resistance and the Fe-based amorphous/nanocrystalline coating showing the least resistance. The rate of volume loss of all the coatings that were studied after 8 h cavitation test decreased with cavitation erosion time, and this trend was pronounced in the WC-10Co4Cr/Co-based composite coating and the Fe-based amorphous/nanocrystalline coating. This decreasing rate of volume loss was likely because of the top layers of the coating were removed at the beginning of cavitation exposure due to the relatively looser outer surface microstructure. The superior cavitation resistance of the WC-10Co-4Cr coating was mainly due to the higher microhardness of the coating, as suggested by Kumar, et al. [6]. The low porosity of the Co-based coating was likely a factor that contributed to the relatively good cavitation resistance of that coating system. For the WC-10Co4Cr/Co-based composite coating, the addition of Co-based metallic alloys adversely affected significantly the cavitation performance of the coating. The WC-10Co4Cr/Co-based composite coatings with reduced cavitation resistance were likely due to their lower hardness and higher porosity (Table 1). The Fe-based amorphous/nanocrystalline coating showed the lowest cavitation resistance, and this was due to its high porosity. It is generally known that cavitation erosion resistance increases with increasing hardness or decreasing porosity [27]. Further, cavitation usually initiates at nucleation sites at or around pores and microcracks in coatings [28]. Thus, the presence of these defects will allow for the perpetuation of cavitation erosion and reduction in cavitation erosion resistance.

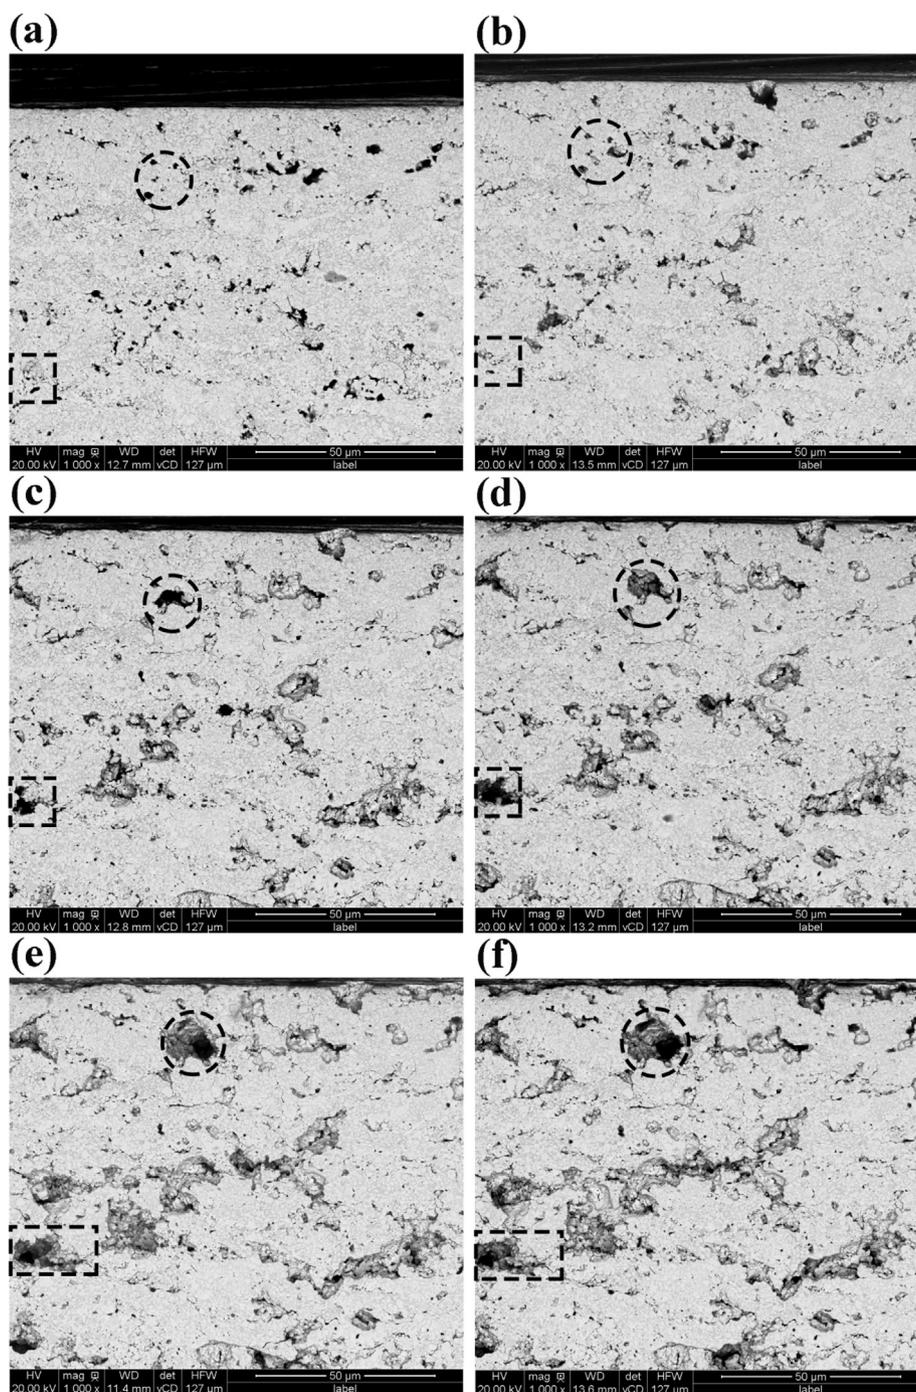
Fig. 4. Typical SEM cross-sectional morphologies of the WC-10Co4Cr coating after (a) 0 h, (b) 4 h, (c) 8 h, (d) 15 h, (e) 25 h, and (f) 35 h of cavitation exposure at the same observation point. A comparison of Fig. 4a–f clearly shows that the pores expanded as erosion time increased. This is highlighted by using dashed rectangles and circles.

In-situ SEM observation was performed in the same region of the cross-section surface of the HVOF-sprayed coatings after different cavitation exposure periods to acquire more detailed information on the cavitation behaviors of the coatings in deionized water. Fig. 4 clearly shows the microstructure evolution of the WC-10Co4Cr coating before erosion and as erosion time increased, in particular, the locations highlighted by dashed rectangle and circle. Before the cavitation test, some pores and microcracks were observed (Fig. 4a), which could be preferentially eroded [29,30]. Some eroded zones appeared in the coating after erosion for 4 h (see Fig. 4b). When eroded for 8 h and further for 15 h, the smaller pores tended to be connected because of the exposure to longer periods of cavitation erosion (Fig. 4c and 4d). With further increase of the erosion time to 25 h, and then to 35 h, larger cracks and distinct craters appeared in the cross-sections that were studied (Fig. 4e and 4f). It has been reported that microcracks that initiate at the edge of pre-existing pores and then propagate along with the carbide-binder interface, leading to plastic deformation of proximate material, resulting in the formation of larger cracks and craters due to pulling out of the carbide phase in the coating [7,31]. Additionally, the cobalt-chromium matrix phase might be preferentially removed during erosion and the unsupported WC grains that remain detach as the erosion test time is increased [32]. This is supported by experimental observations shown in Fig. 3a, wherein the cumulative

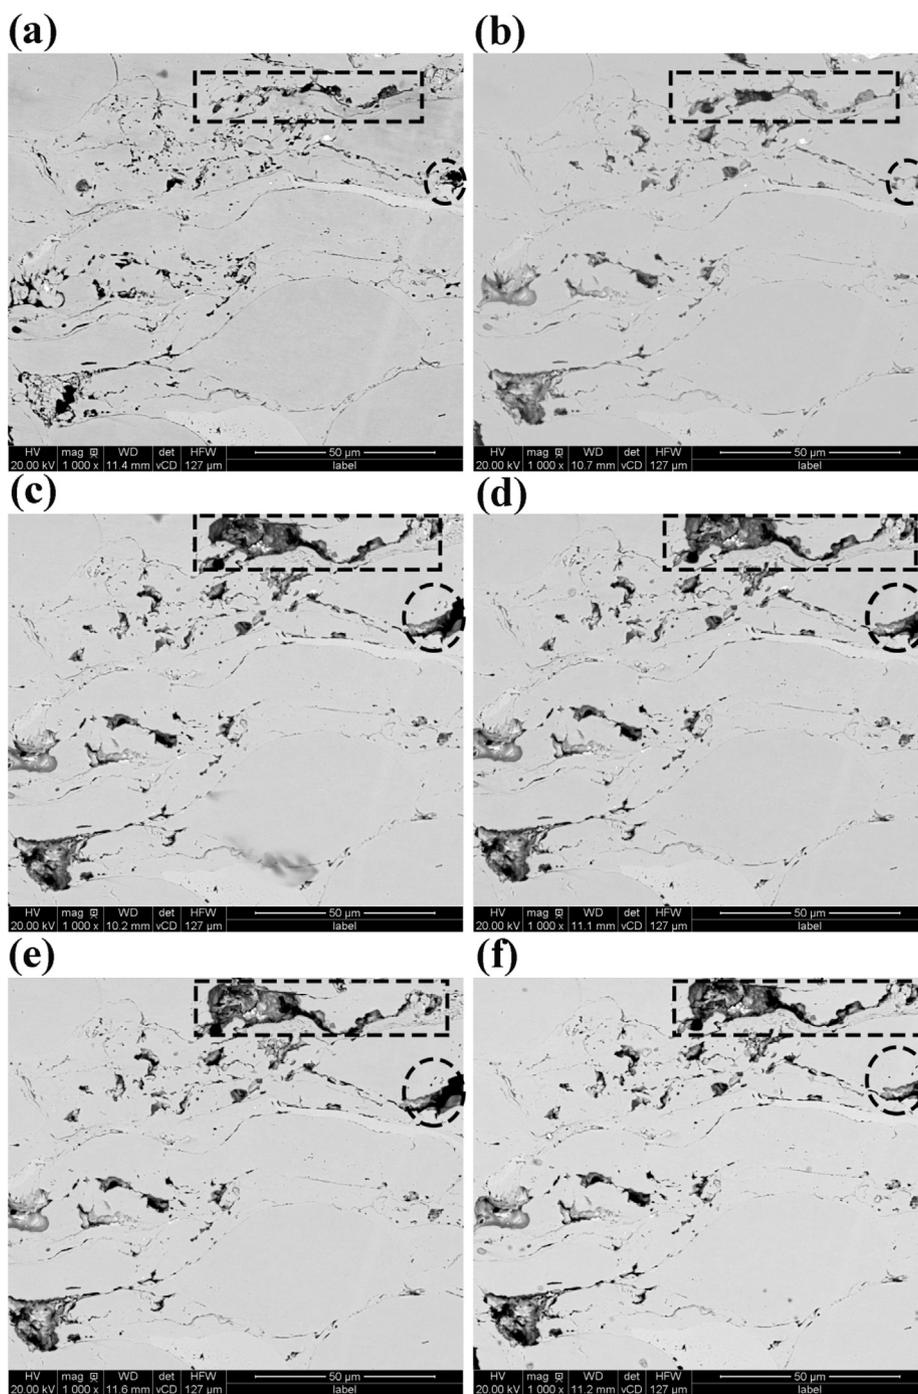
Fig. 5. Typical SEM cross-sectional morphologies of the Co-based coating after (a) 0 h, (b) 4 h, (c) 8 h, (d) 15 h, (e) 25 h, and (f) 35 h of cavitation exposure periods at the same observation point. A comparison of Fig. 5a–f clearly shows that the cracks and pores expanded as erosion time increased. This is highlighted by using dashed rectangles and circles.

For the Co-based coating (Fig. 5), typical defects including pores, partially molten particles, and cracks were observed in the coating before cavitation erosion testing (Fig. 5a). The cracks and the pores gradually connected after eroded for 4 h (Fig. 5b). It was likely due to the presence of the pre-existing pores around the cracks, and the proximate pores and cracks expanded and easily connect together finally under repeated cavitation erosion loading. The sudden collision due to the energetic bursting of bubbles may initiate microcracks. When eroded for 8 h and further to 35 h, as can be seen in Fig. 5c to 5f, additional cracks and craters were observed along with defects created by features such as splat boundaries. It has been reported that cracks preferentially propagate along interlamellar and individual splat boundaries because of the lower cohesive strengths of the coating at these locations [29]. Stress wave propagation will lead to the formation of cracks, and on the other hand, hydraulic penetration will induce enlargement of existing cracks [33]. The failure mode may depend on the toughness of the coating in the later stage of cavitation erosion. Large particles were detached due to the coalescence of fatigue cracks under the coating surface. It was also reported that plastic deformation would cause the enlargement of cracks and form void, and the adjacent voids coalesce, resulting in eventual material loss [34].

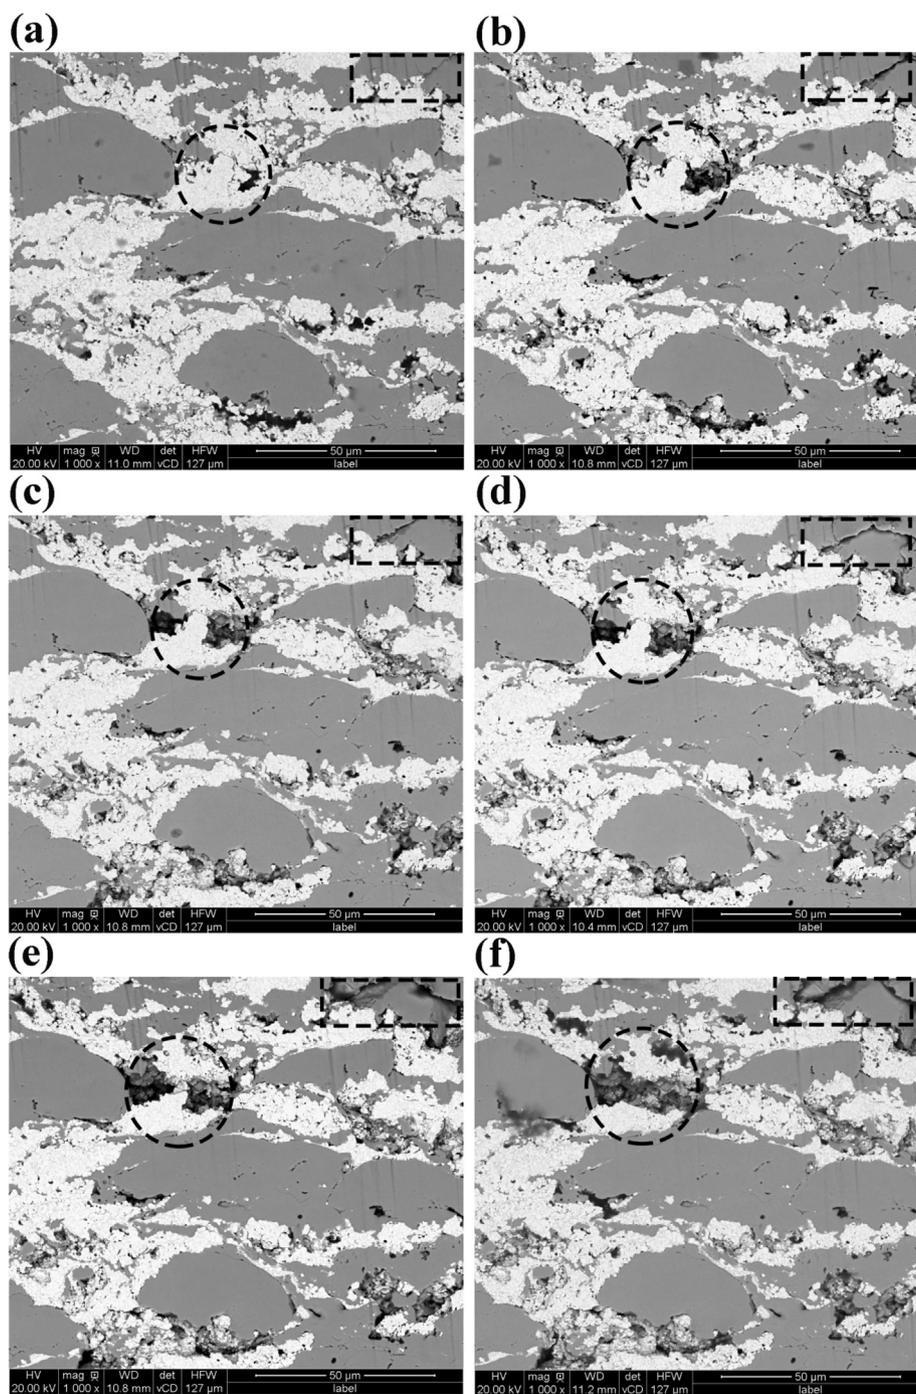
Fig. 6. Typical SEM cross-sectional morphologies of the WC-10Co4Cr/Co-based composite coating after (a) 0 h, (b) 4 h, (c) 8 h, (d) 15 h, (e) 25 h, and (f) 35 h of cavitation exposure periods at the same observation point. A comparison of Fig. 6a–f clearly shows that the cracks and pores expanded as erosion time increased. This is highlighted by using dashed rectangles and circles.

For the WC-10Co4Cr/Co-based composite coating (Fig. 6), it could be seen from the as-sprayed composite coating that pores were mainly present in the WC-10Co4Cr phase and microcracks were observed in the Co-based phase (Fig. 6a). As is observed in Fig. 6b–e, the pores and microcracks showed a significant expansion and began to form craters and larger cracks ultimately. Larger craters were formed in the WC-10Co4Cr phase, whereas the extension of microcracks in the Co-based phase was not apparent. This was due to much more defects were present in the WC-10Co4Cr phase than those in the Co-based phase, while damage of the coating usually originated from the defects. Although the WC-10Co4Cr phase possesses excellent physical properties such as high hardness [35], the surface was significantly eroded due to the presence of pores. With further increase of the erosion time to 35 h, larger cavitation craters appeared in the reinforcing particulate phases (WC-10Co4Cr) of the coating by connecting the proximate craters and pores because of the exposure to longer periods of cavitation erosion, while no significant change was observed in the soft matrix phase (Co-based) compared with the result of the erosion time of 25 h (Fig. 6f). The result indicates that defects (such as pores and cracks) in the WC-10Co4Cr/Co-based composite coating were more critical than physical properties (such as hardness) in the cavitation erosion process.

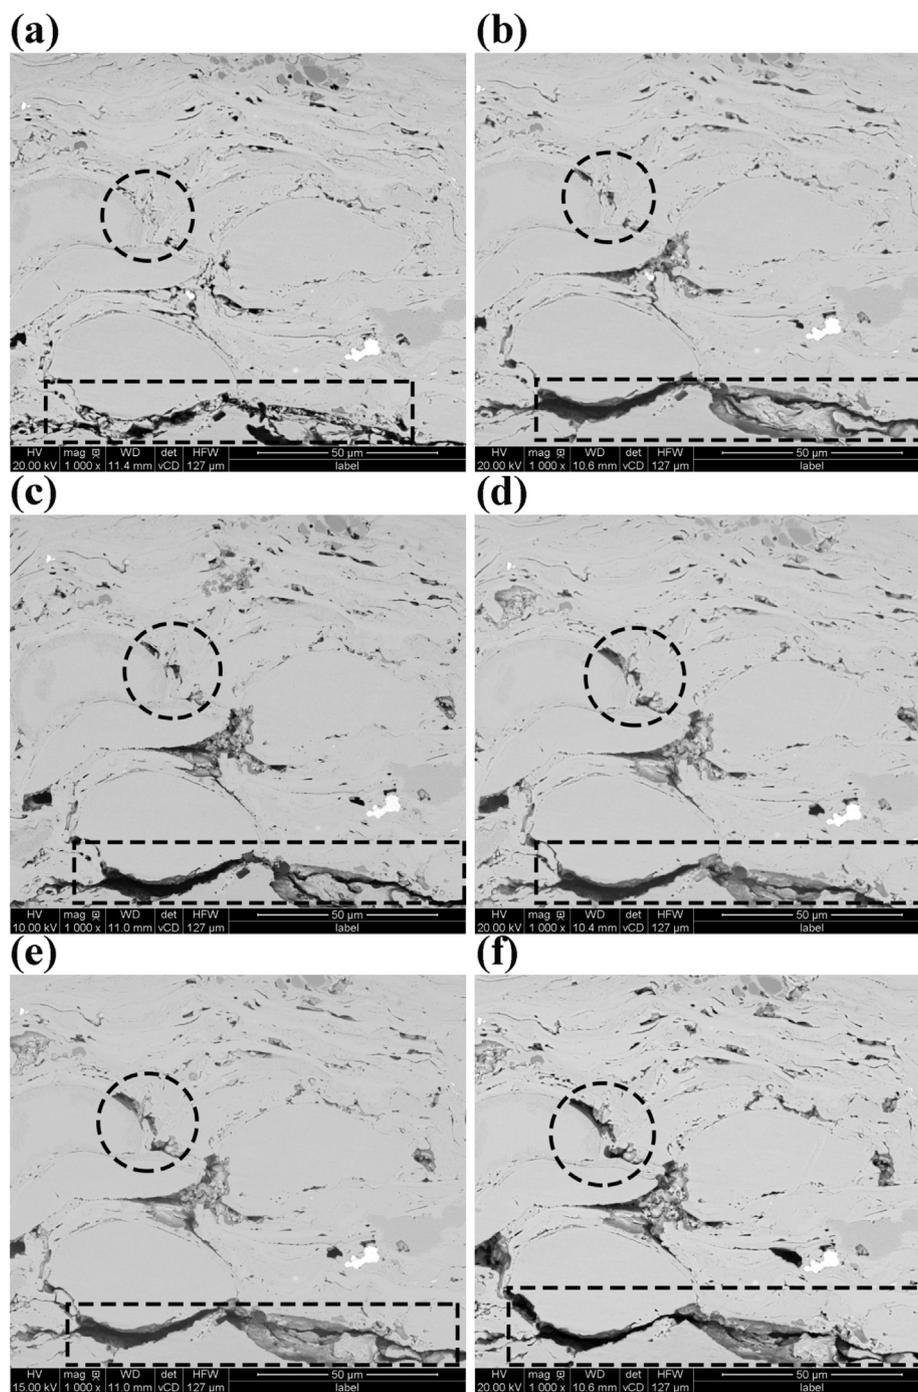
Fig. 7. Typical SEM cross-sectional morphologies of the Fe-based amorphous/nanocrystalline coating after (a) 0 h, (b) 4 h, (c) 8 h, (d) 15 h, (e) 25 h, and (f) 35 h of cavitation exposure periods at the same observation point. A comparison of Fig. 7a–f clearly shows that the cracks and pores expanded as erosion time increased. This is highlighted by using dashed rectangles and circles.

Cracks growth initiated easily at the particle boundaries in the Fe-based amorphous/nanocrystalline coating (see Fig. 7). Some of these cracks were pre-existing in the as-sprayed coating, as shown in Fig. 7a,

with evidence of pores present inside the cracks. It was reported that damage of the Fe-based amorphous/nanocrystalline coating originated from the micro-pores [36]. Pores near the coating surface significantly accelerated the cavitation erosion process via mechanical and chemical erosion. Fig. 7b shows that the pores and microcracks became larger after erosion for 4 h. Under these circumstances, it is hypothesized that the collapse of cavitation bubbles induced the formation of deep cracks that penetrated into the coating. With further increases of the cavitation time to 8 h and then to 25 h, a gradual increase in the size of the craters and cracks occurred (Fig. 7c–e). With the loss of the Fe-based amorphous/nanocrystalline coating material, the pores inside the microcracks gradually became larger and then coalesced to form large cracks

or craters through combination with patulous microcracks during erosion loading. When the cavitation erosion time was increased to 35 h for more aggressive erosion, the microcracks coalesced, and resulted in the detachment of portions of the coating (Fig. 7f)). The microcracks that were initiated at the interfaces between the partially molten particles eventually led to cohesive delamination of the Fe-based amorphous/nanocrystalline coating, as suggested by Qial, et al. [27]. Most of the material loss that occurred may have started at the edges of the particles and the internal splats due to the presence of the partially molten particles and pores around them [16]. In these regions of the coating where abrupt physical changes in the microstructure occurred, it was likely that local stress concentration during erosive loading was

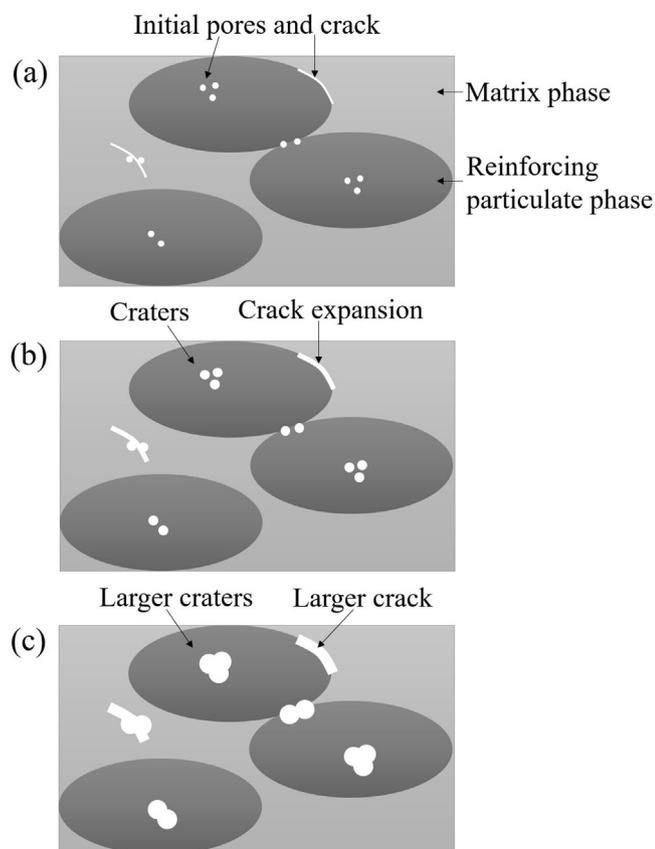
Fig. 8. Schematic diagram of the cavitation erosion process and mechanism.

The *in-situ* SEM analysis that was conducted in this study has enabled elucidation of the failure mechanisms of HVOF-sprayed coatings in deionized water. Fig. 8 presents an illustration of the possible failure mechanisms. Fig. 8a, in particular, corresponds to the original polished surface of the coating, which comprised of a few pores and cracks. The distribution of the pores and cracks are often present in both the matrix and reinforcing particulate phases or at the interface between the

partially molten particles and the fully molten splats. Once the cavitation erosion testing is initiated, the alternating pressure that is caused by ultrasound waves results in the nucleation and collapse of cavitation bubbles, and the formation of defects such as cracks and pores on the surface promote further nucleation, growth, and collapse of bubbles around those defects. Cavitation erosion damage initially occurs at or around pre-existing pores and cracks and then increases during the cavitation erosion process (Fig. 8b). The repeated loading and induced stresses due to shock waves that act on the surface has the noticeable effect of causing the transformation of pores to craters during the cavitation erosion process. The expanded cracks, pores, and craters merge and result in the detachment and loss of coating material under

repeated cavitation erosion loading (Fig. 8c). It has been reported that the difference in cavitation erosion rate was mainly due to microstructural features of the coatings [10]. However, it is noteworthy that although the microstructure of the coatings significantly affects the cavitation behavior of the coatings, the final cavitation erosion rates of the coatings appear to be more related to the physical properties of the coating samples in this study, such as hardness. Moreover, and interestingly, in the composite coating with hard reinforcing particulate phases and soft metal matrix phases, cavitation damage is considerably slower in defect-free metal matrix phase areas than in porous hard reinforcing particulate phase areas, as observed from the results shown in Figs. 6 and 8. Taken together, these suggest that the mechanisms of
